Sulfuric Acid Flange Repairs with Belzona 4301

Industry: Oil & Gas
Application: VPF-Valves, Pipes and Fittings
Substrate: Carbon steel
Products: Belzona 4301 (Magma CR1 Hi-Build)

Customer Location: Addis, Louisiana
Application Date: April 2024

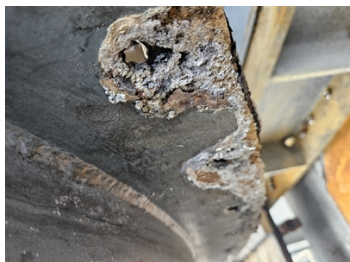
Damaged Flange from sulfuric acid.

Flange with Sulfuric Acid Damage

- prepared the substrate on the damaged area as listed and points surrounding the damaged area.
- Applied Belzona 4301 system to the area of repair as listed.
- Allowed full cure of product prior to applying any chemicals, this took 4-Days at 86 degrees F.

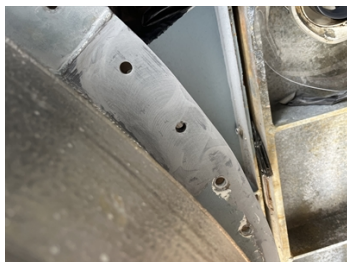
Flange After Repair with Belzona 4301

Profile of 3 mils

Blasted clean to SSPC SP 10

Utilized stiff Bristle brush to apply fully conditioned Belzona 4301

Waited for full cure
