# Belzona Florida Repairs Steel Mill

ID: 9416

Industry: *Steel & Metal Processing*  
Application: *ENC-Engines and Casings*  
Substrate: *Stainless-steel*  
Products: *Belzona 1212*

Customer Location: *Duval County, Florida*  
Application Date: *2021*

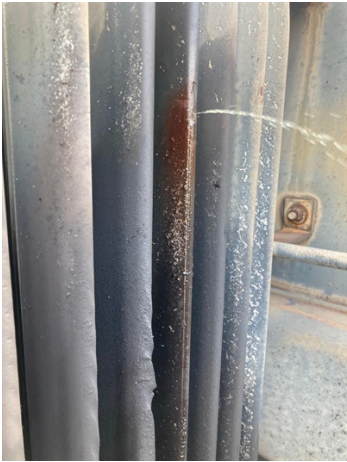
*The transformer could not be shut down and the leak was live. It was constantly spitting a stream of cooling oil.*

Leaking transformer

The leak persisted continuously, and shutting down the transformer was not feasible. According to the onsite engineer, an alternative repair approach, involving shutting down the transformer and draining the cooling oil to a level that would allow cleaning the area and welding the hole, was estimated to cost approximately \$30,000. Instead, we effectively plugged the leak using a single 450g unit of Belzona 1212, which cost approximately \$130.

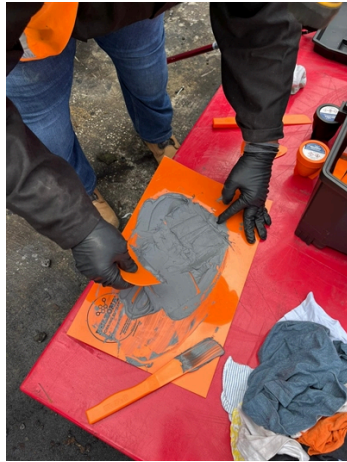
Mixing the product together

While on site, we did not have Belzona 9611 available, so we prepared a batch of Belzona 1212. We allowed the mixture to reach the six-minute mark of its working life, during which it warmed up and began to cure. At this point, the Belzona 1212 material had hardened sufficiently to be used as a plug. Using a Belzona applicator, we pressed the Belzona 1212 into the live leak hole, effectively sealing it instantly. We also provided instructions to the onsite technicians on how to mix and apply the material. This repair was performed three years ago and remains effective to this day.

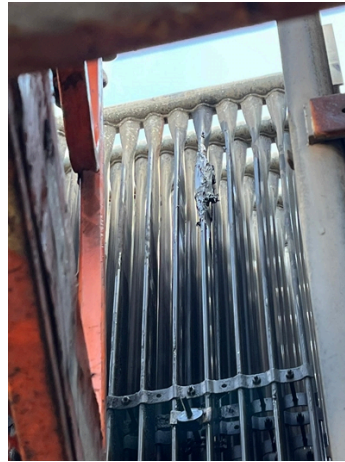
Area completely repaired using the product
