Sealing of gas pipe expansion joints.

ID: 9418

Industry: *Steel & Metal Processing*
Application: *GSS-Gaskets, Seals and Shims*
Substrate: *Stainless-steel*
Products: *Belzona 2311 (SR Elastomer), Belzona 7311*

Customer Location: *Kosice*
Application Date: *August 2023*

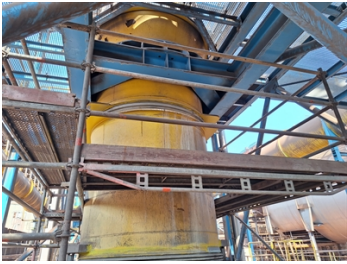
At the pipe/expansion joint, due to expansion and weather conditions, the expansion jointer was torn off locally and a subsequent leak occurred.

The expansion jointer was torn off locally and a subsequent leak occurred.
