Treatment of the water chambers of the exchanger.

ID: 9420

Application: *HEX-Heat Exchangers*

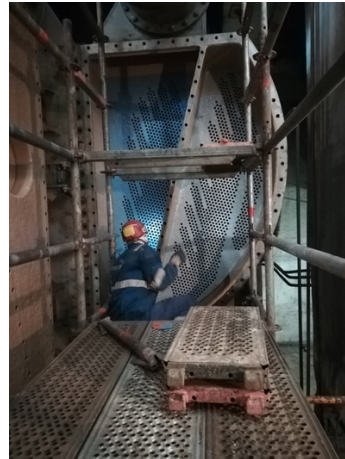
Application of the first layer of Belzona 1341.

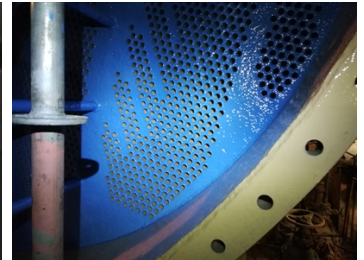
Application of the second layer of Belzona 1341.
