Protection of the inside of the filter housing.

Industry: *Steel & Metal Processing*
Application: *TCC-Tanks and Chemical Containment Areas*
Substrate: *Carbon steel*
Products: *Belzona 1341 (Supermetalglide)*

Customer Location: *Kosice*
Application Date: *April 2023*

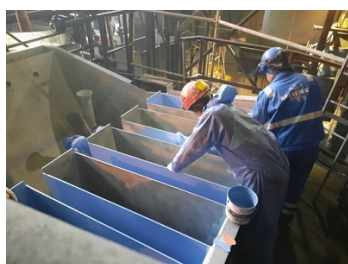
Application of the first layer of Belzona 1341.
