Silo cone gap sealing

ID: 9424

Application: RPA-Roof Problem Areas

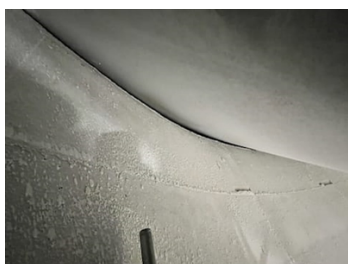
White cement was falling off from a gap between the silo cone and the concrete wall which poses safety concerns for the employees.

Gap between Silo cone before cleaning

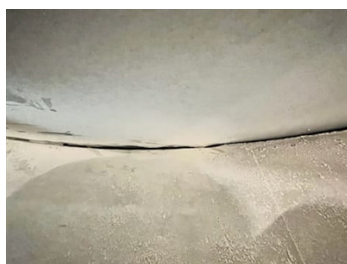
Gap before surface preparation.

A blower was used to remove cement from the surface and surroundings. Belzona 91111 was used to clean the surface. Belzona 1121 was then injected using Belzona pneumatic pistol into the gap to seal off the falling materials. Additional material was applied using Belzona applicator to make sure the area is well sealed.

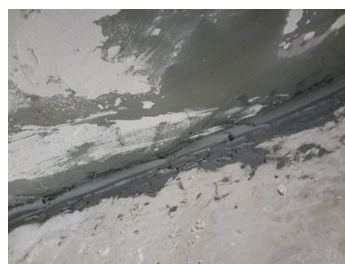
Gap after sealing with Belzona 1111.

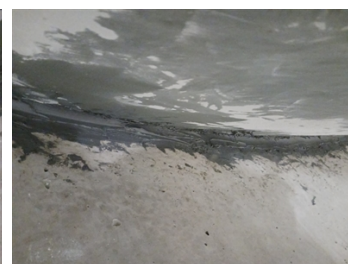
Final sealing with Belzona 1111.

Product cured on multiple substrate and the gap was sealed. After 24 hours, an inspection by the production team confirmed that materials were no longer falling from the gap hereby confirming a perfect seal. Customer is looking at sealing up such gaps with Belzona in the nearest future.
