Belzona 5871 Insulates Ammonia Pipes

ID: 9426

Industry: Commercial Facilities
Application: VPF-Valves, Pipes and Fittings
Substrate: Carbon steel
Products: Belzona 5871

Customer Location: Carolina
Application Date: May 2024

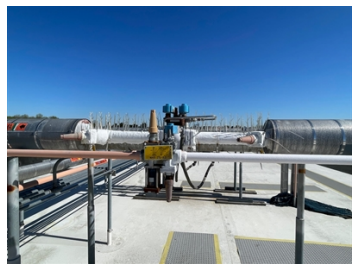
This Distribution Center roof housed between 50 and 60 ammonia pipes. Due to moisture on the pipes, birds were pecking at the original coating and insects were getting stuck. This resulted in the maintenance team having to re apply the coating every year.

Ammonia pipes

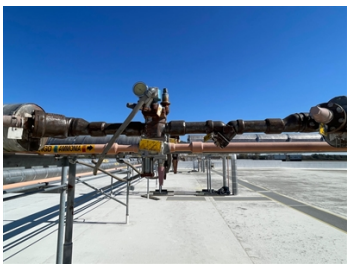
Cladding removed

The pipe insulation was removed and the pipes were prepared using an MBX Bristle Blaster. No grinding was required which ensured the pipes could stay online during the repair. One layer of Belzona 5871 was applied directly to the surface using a short bristled brush. The product expanded upon application and produced a lightweight, closed-cell foam, insulating the pipe. This application followed a modified VPF-12 procedure.

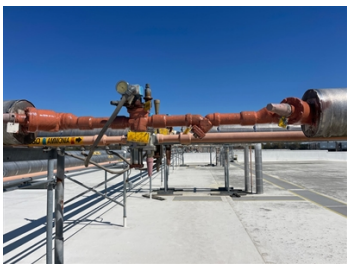
Belzona 5871 applied

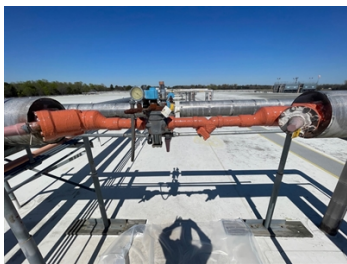
Belzona 5871 applied
