# Belzona 5871 Insulates Ammonia Pipes

ID: 9426

Industry: Commercial Facilities  
Application: VPF-Valves, Pipes and Fittings  
Substrate: Carbon steel  
Products: Belzona 5871

Customer Location: Carolina  
Application Date: May 2024

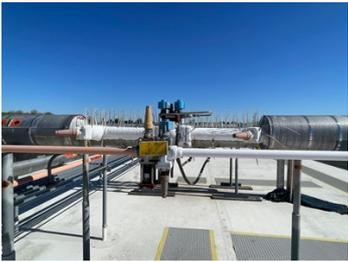
This Distribution Center roof housed between 50 and 60 ammonia pipes. Due to moisture on the pipes, birds were pecking at the original coating and insects were getting stuck. This resulted in the maintenance team having to re-apply the coating every year.

Ammonia pipes

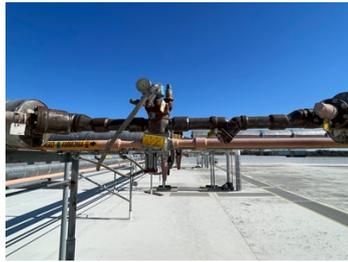
Cladding removed

The pipe insulation was removed and the pipes were prepared using an MBX Bristle Blaster. No grinding was required which ensured the pipes could stay online during the repair. One layer of Belzona 5871 was applied directly to the surface using a short bristled brush. The product expanded upon application and produced a lightweight, closed-cell foam, insulating the pipe. This application followed a modified VPF-12 procedure.

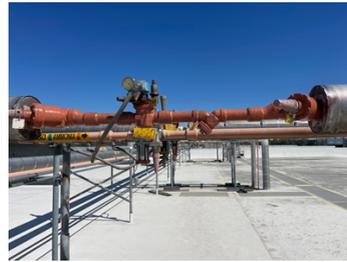
Belzona 5871 applied

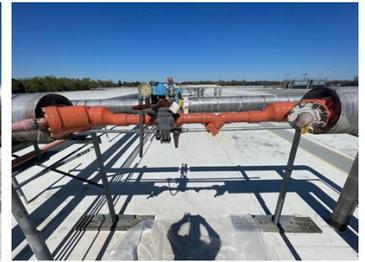
Belzona 5871 applied
