# Wind Turbine Blades

ID: 9436

Industry: Power  
Application: FBC-Fans, Blowers and Compressors

Customer Location: Denmark  
Application Date: September 2023

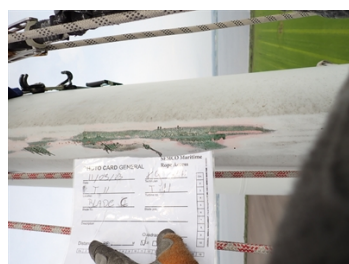
Wind turbine in need of repair and protection

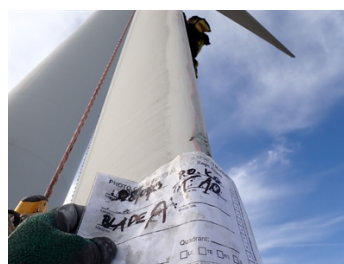
Application of Belzona 5711 and Belzona 5721 completed

Surface preparation was carried out, followed by the direct application of 90 kg (198.4 lbs) of Belzona 5711 from self-mixing cartridges onto the blade. The repair area was contoured using a piece of Belzona mixing board. Once cured, a visual inspection was conducted to ensure the application's readiness for overcoating with 144 kg (317.5 lbs) of Belzona 5721. Using a short-bristled brush, this system was then applied to the leading edge and left to cure. The application was carried out in accordance with Belzona System Leaflet FBC -16.
