# Refurbishment of a marine caisson

ID: 9439

Industry: *Marine* Customer Location: *France*  
Application: *CEP-Centrifugal Pumps* Application Date:  
Substrate: *Stainless-steel*  
Products: *Belzona 1111 (Super Metal), Belzona 1331, Belzona 5811 (Immersion Grade)*

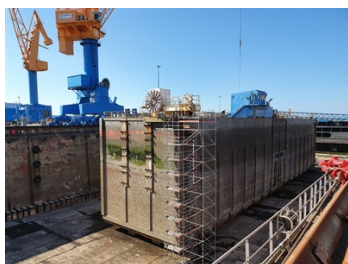
*This caisson was suffering from significant corrosion, leading to an ineffective seal. The two steel installation surfaces (18000 x 1100 mm), sealed in the concrete of the boat-carrier, were completely corroded and damaged. The surface condition no longer made it possible to obtain full waterproofing when installing the louver closing seal.*

Caisson before the Belzona repair

The client was responsible for setting up the scaffolding and washing HP and salt away for saline decontamination. Alliatech could then begin the application with sandblasting (SA2.5 /75µ roughness) and application of Belzona 5811 in 250µm to prevent corrosion before rebuilding with Belzona 1111. For final protection, two coats of Belzona 1331 were applied with a brush.

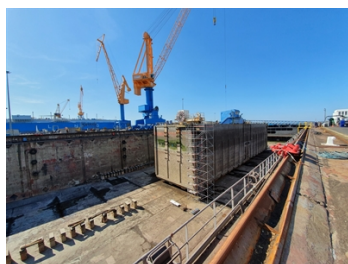
Caisson before the Belzona repair from a different perspective

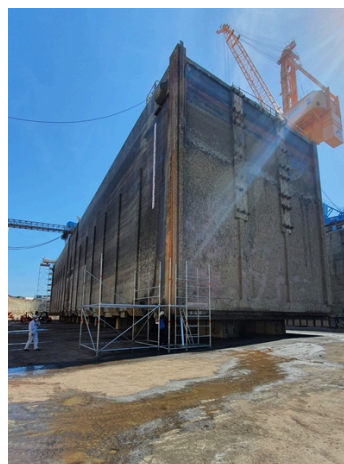
Caisson after the Belzona repair
