Refurbishment of a marine caisson

ID: 9439

Industry: *Marine* Customer Location: *France*
Application: *CEP-Centrifugal Pumps* Application Date:
Substrate: *Stainless-steel*
Products: *Belzona 1111 (Super Metal), Belzona 1331, Belzona 5811 (Immersion Grade)*

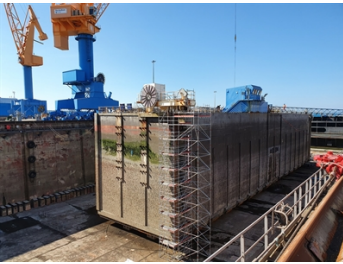
This caisson was suffering from significant corrosion, leading to an ineffective seal. The two steel installation surfaces (18000 x 1100 mm), sealed in the concrete of the boat-carrier, were completely corroded and damaged. The surface condition no longer made it possible to obtain full waterproofing when installing the louver closing seal.

Caisson before the Belzona repair

The client was responsible for setting up the scaffolding and washing HP and salt away for saline decontamination. Alliatech could then begin the application with sandblasting (SA2.5 /75µ roughness) and application of Belzona 5811 in 250µm to prevent corrosion before rebuilding with Belzona 1111. For final protection, two coats of Belzona 1331 were applied with a brush.

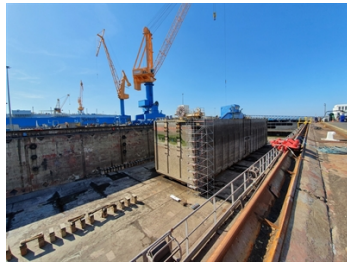
Caisson before the Belzona repair from a different perspective

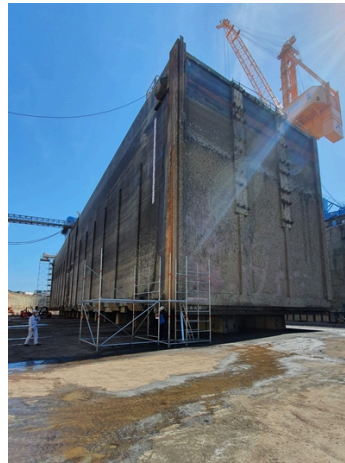
Caisson after the Belzona repair
