Concrete Repair in Wastewater Clarifier

ID: 9442

Application: TCC-Tanks and Chemical Containment Areas

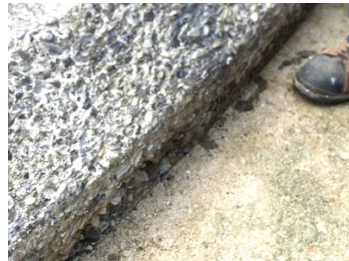
Constant water running over the weirs has caused damage to the concrete

Clarifier was pressure washed and any loose concrete was removed Belzona 4131 and conditioner was applied according to IFU.

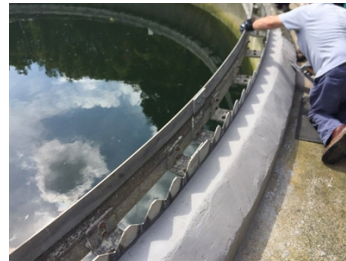
Damage after it was cleaned.

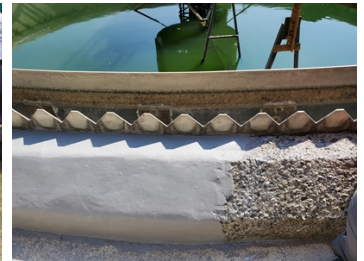
Applying Belzona 4131
