# Concrete Repair in Wastewater Clarifier

ID: 9442

Products: Belzona 4131 (Magma-Screed), Belzona 4911 (Magma TX Conditioner)

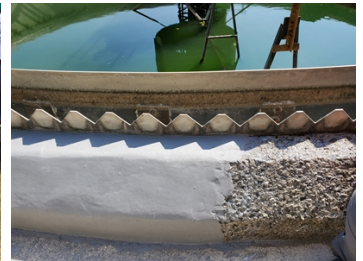
Before and after.
