Chemical Containment Area

ID: 9443

Industry: Chemical & Petrochemical
Application: TCC-Tanks and Chemical Containment Areas
Substrate: Concrete
Products: Belzona 4311 (Magma CR1), Belzona 4911 (Magma TX Conditioner)

Customer Location: GA
Application Date: May 2024

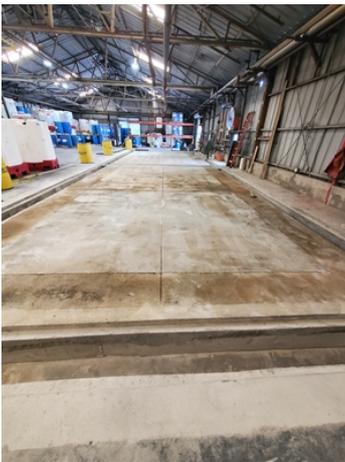
New uncoated containment area

The new concrete was over 30 days old. It was pressure washed and allowed to dry then a grinder was used to give a profile on the concrete, It was cleaned again to remove the dust. Belzona 4911 primer was applied, then Belzona 4311 second coat of Belzona 4311 Grey followed Red.

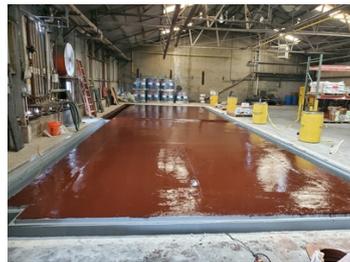
The first coat of Belzona 4311

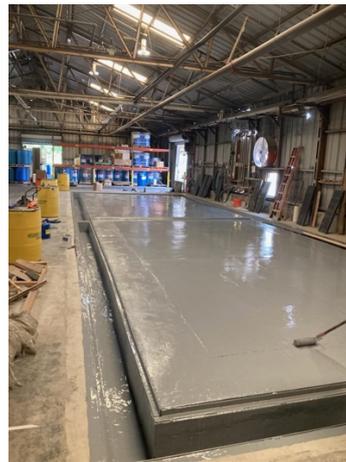
The second coat of Belzona 4311

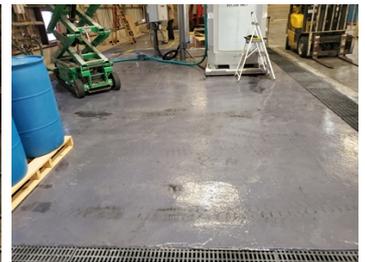
Follow up picture
