# Chemical Containment Area

ID: 9443

Industry: *Chemical & Petrochemical* Customer Location: *GA*  
 Application: *TCC-Tanks and Chemical Containment Areas* Application Date: *May 2024*  
 Substrate: *Concrete*  
 Products: *Belzona 4311 (Magma CR1), Belzona 4911 (Magma TX Conditioner)*

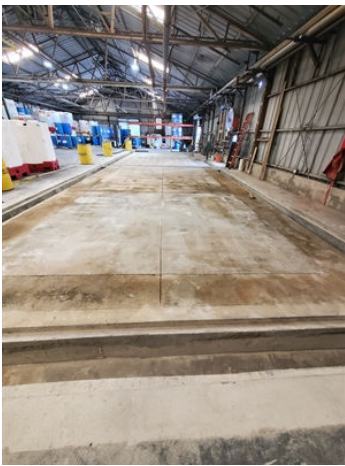
New uncoated containment area

The new concrete was over 30 days old. It was pressure washed and allowed to dry then a grinder was used to give a profile on the concrete, It was cleaned again to remove the dust. Belzona 4911 primer was applied, then Belzona 4311 second coat of Belzona 4311 Grey followed Red.

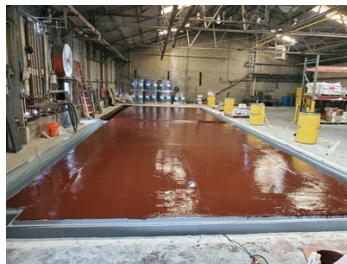
The first coat of Belzona 4311

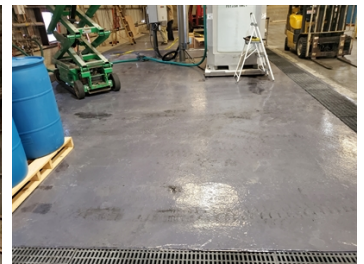
Follow up picture
