Belzona Salvages an Aquarium Pump Intake

Application: PDP-Positive Displacement Pumps

Substrate: Cast Iron

Products: Belzona 1111 (Super Metal), Belzona 1341N (Supermetalglide)

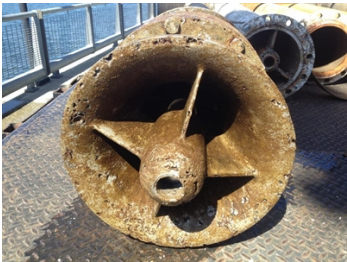
This salt water intake pump had heavy erosion, suspected to be caused by galvanic corrosion.

Original condition when removed from the salt water.

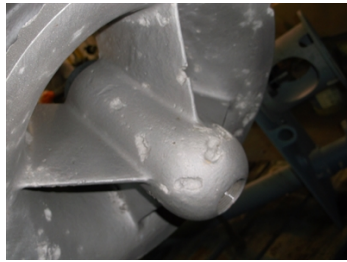
Grit blasted and ready for Belzona 1111.

Grit blasting was used to remove all surface contamination and prepare the surface according to the Instructions For Use for both Belzona 1111 and Belzona 1341N. The Belzona 1111 was applied with Belzona applicators and allowed to cure, then hand sanded to achieve a smooth profile. The piece was then lightly grit blasted again prior to the application of the Belzona 1341N by brush.

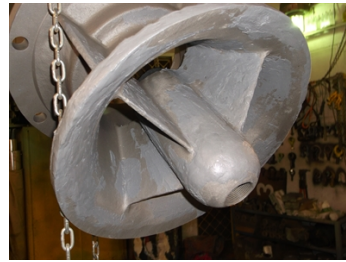
Belzona 1111 applied.

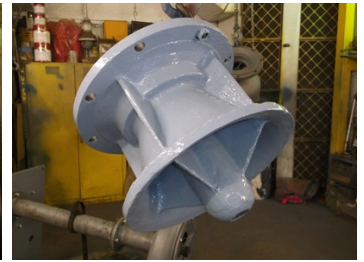
Protected with two coats of Belzona 1341N.
