# Belzona 1111 Can Rebuild Severe Pump Corrosion

Industry: *Not Specified*  
 Application: *PDP-Positive Displacement Pumps*

Substrate: *Cast Iron*  
 Products: *Belzona 1111 (Super Metal)*

*Heavy metal loss on the internal components of a multi-stage vertical salt water pump.*

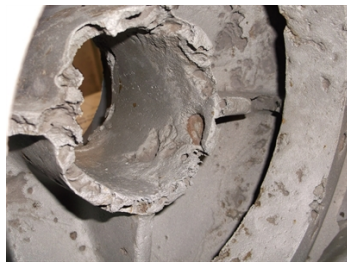
Original condition after opening the pump.

Deep pitting on the internal parts were causing poor performance with this pump.

Grit blasting to prepare the surface according to the Belzona 1111 Instructions For Use. Then the Belzona 1111 was applied by hand using the Belzona applicator. Once cured, the application was hand sanded to the original profile and coated with two full coats of Belzona 1341N.

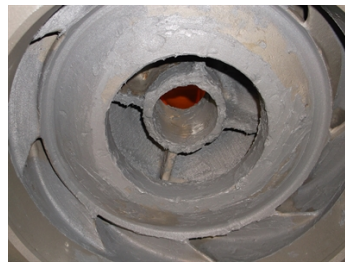
Up close view of the damage.

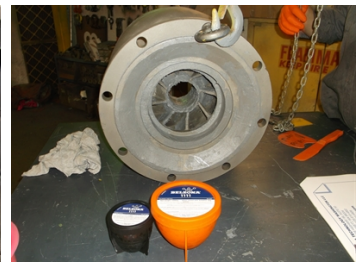
Belzona 1111 filling in all of the damage and correcting the profile.
