Belzona 1111 keeps the 210' Cutter safe.

ID: 9452

Application: SOS-Ships and Offshore Structures

Products: Belzona 1111 (Super Metal), Belzona 9411 (Release Agent)

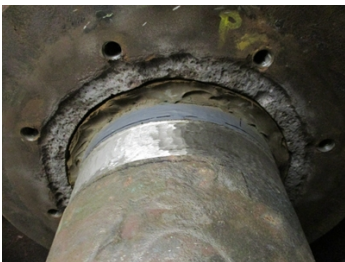
The shaft and gasket seal face were eroded from salt water corrosion on both propulsion shafts.

Showing the area of damage to the shaft and gasket surface prepped.

The shaft was prepped with a hand grinder removing roughly 1/4" of damaged shaft to allow for a decent bed of Belzona 1111. The gasket surface was hand prepped using an MBX Bristleblaster since the damage was fairly deep. Belzona 9411 was liberally applied to the formers in two coats to ensure a good release. Belzona 1111 was applied with a short bristle brush to the application area, and then to both surfaces in thin layers to avoid any air pockets. The formers were then put in place and tightened down being sure that excess Belzona 1111 squeezed out from all sides. Once the Belzona 1111 was cured, the formers were carefully removed, and the application areas dressed down with emery cloth on the shafts and hand sanding blocks on the gasket surface.

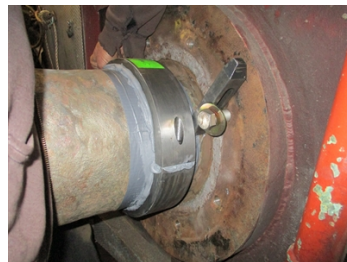
The shaft former in place showing the excess Belzona 1111 squeezing out.

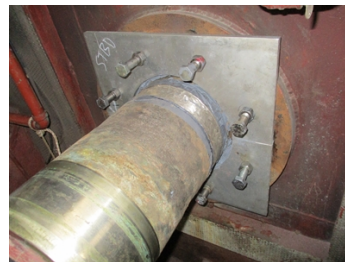
The gasket area former in place with Belzona 1111.

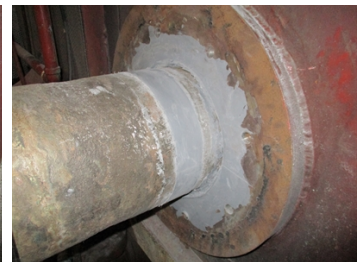
Application complete showing the initial clean up.
