## Belzona 1111 keeps the 210' Cutter safe.

Application: SOS-Ships and Offshore Structures

Products: Belzona 1111 (Super Metal), Belzona 9411 (Release Agent)

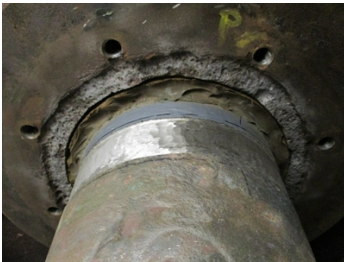
The shaft and gasket seal face were eroded from salt water corrosion on both propulsion shafts.

Showing the area of damage to the shaft and gasket surface prepped.

The shaft was prepped with a hand grinder removing roughly 1/4" of damaged shaft to allow for a decent bed of Belzona 1111. The gasket surface was hand prepped using an MBX Bristleblaster since the damage was fairly deep. Belzona 9411 was liberally applied to the formers in two coats to ensure a good release. Belzona 1111 was applied with a short bristle brush to the application area, and then to both surfaces in thin layers to avoid any air pockets. The formers were then put in place and tightened down being sure that excess Belzona 1111 squeezed out from all sides. Once the Belzona 1111 was cured, the formers were carefully removed, and the application areas dressed down with emery cloth on the shafts and hand sanding blocks on the gasket surface.

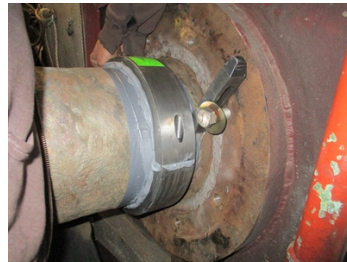
The shaft former in place showing the excess Belzona 1111 squeezing out.

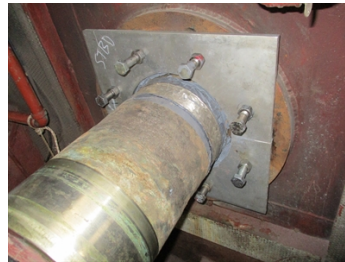
The gasket area former in place with Belzona 1111.

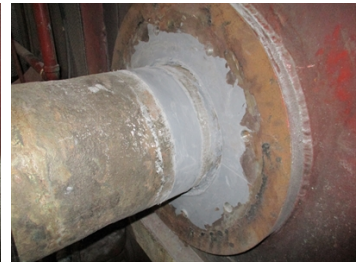
Application complete showing the initial clean up.
