Belzona Protects Against Impeller Wear

ID: 9453

Industry: Water / Wastewater
Application: CEP-Centrifugal Pumps
Substrate: Carbon steel
Products: Belzona 1311 (Ceramic R-Metal), Belzona 1321 (Ceramic S-Metal)

Customer Location: Washington
Application Date: July 2015

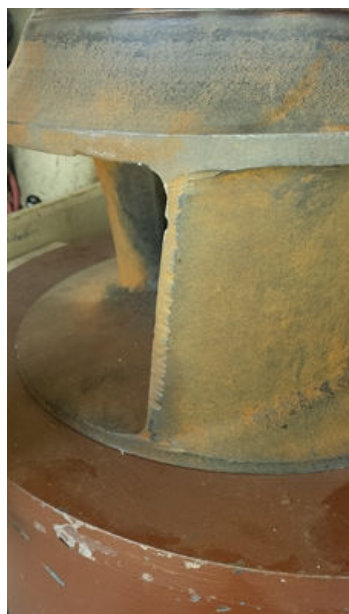
This wastewater impeller was suffering from abrasive wear.

Showing some of the wear.

This impeller was showing the early stages of abrasive wear from wastewater solids. The customer wanted to repair the damage, and protect it from further damage. For only a couple hundred USD, this impeller was protected and returned to service in two days.

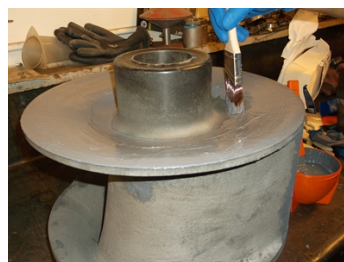
Applying the first coat of Belzona 1321.

The impeller was grit blasted in the customers blasting booth and rinsed of with acetone solvent before applying the Belzona 1311. Once the Belzona 1311 was firm enough, the first coat of Belzona 1321 was applied, and after a couple hours (per the Instructions For Use) the customer applied the second coat of Belzona 1321.

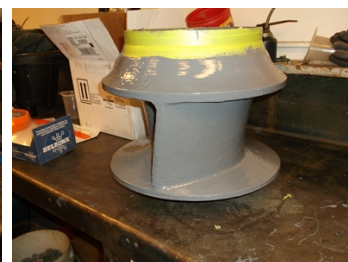
First coat of Belzona 1321 complete.
