Belzona 4111 Refurbishes the Ball Mill Ends

Industry: Mining & Quarrying
Application: SHM-Solids Handling Machinery

Substrate: Cast Iron
Products: Belzona 4111 (Magma-Quartz), Belzona 4911 (Magma TX Conditioner)

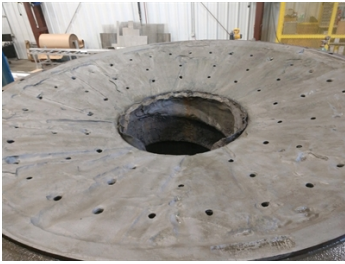
The ball mill ends had heavy wear and erosion.

Showing the damage to the surface.

The ball mill ends had heavy wear and erosion under the wear plates. Welding was not an option as it would cause immense heat stress and would require many hours of labor welding, and then need to be transported to a large enough mill to turn it down to the desired profile. By using Belzona 4111, the application was completed within one day, was allowed to cure overnight, and was shipped to the customer the following day for installation.

The surface was grit blasted and solvent washed. The Belzona 4111 was applied by trowel and hand, pushing it firmly into the uneven surface, and checked for the proper finish using an aluminum straight edge.

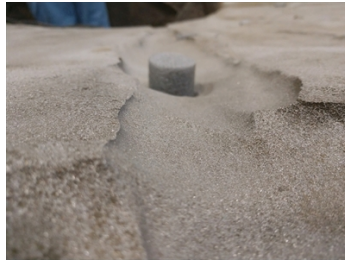
Backer rods inserted into the wear plate mounting holes and showing the target profile height.

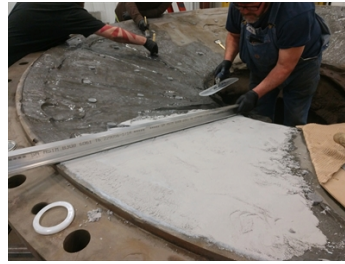
Applying Belzona 4911 Conditioner in the background, and applying Belzona 4111 using a guide to achieve the proper profile.
