Belzona 4111 Makes For A Smooth Floor

Application: FPA-Floor Problem Areas

Substrate: Concrete

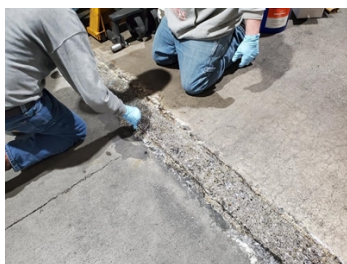
One of the damaged areas in a doorway.

The damaged concrete areas were prepped with a hand grinder and wire wheel to remove all loose material and roughen the surface. The Belzona 4911 conditioner was applied with a short bristled brush, and the Belzona 4111 was applied by hand, pushed firmly into the repair areas, and finished with a steel trowel.

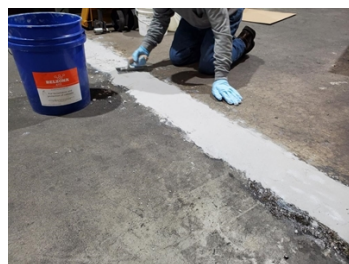
Damaged doorway area repaired.

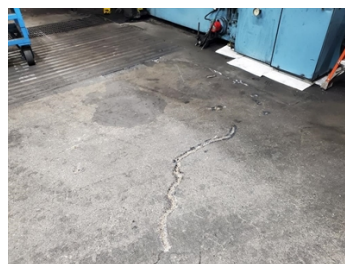
Showing several areas of damage near a machine.

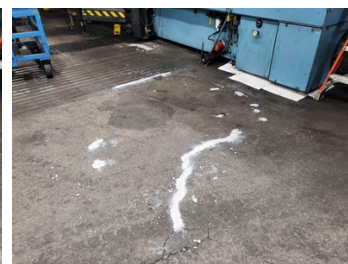
Several damaged areas repaired.
