Belzona 1111 Fixes Pitting on a Wicket Gate

Industry: *Power*
 Application: *CEP-Centrifugal Pumps*
 Substrate: *Carbon steel*
 Products: *Belzona 1111 (Super Metal)*

Customer Location: *Washington*
 Application Date: *January 2017*

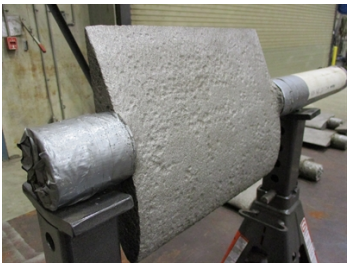
Full spread corrosion and erosion on the body of these wicket gates.

Heavy widespread pitting on all surfaces of these wicket gates needed to be repaired. Belzona 1111 was chosen for its ability to be mixed in smaller amounts as needed, its working life, and being 100% solids that would not shrink, and was 100% machinable once cured. The added bonus was no bad chemical smells which made for a pleasant application.

The customer had a nice sand blasting booth on-site, and were able to use alumina oxide to achieve a 3-5 mil profile. Once blasted, they were washed with acetone, and the Belzona 1111 carefully was applied by hand leaving very little to be hand sanded once it had cured.

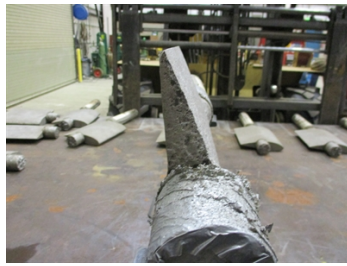
Pitting on the face.

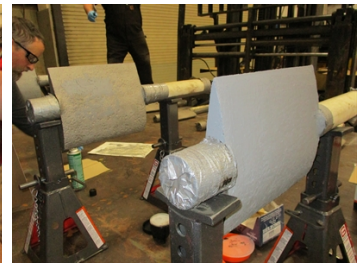
Applying the Belzona 1111.

Application completed on this wicket gate.

Welding had been their previous solution, but they chose to use Belzona 1111 because of a faster return to service, and no unnecessary heat stress would occur. All 12 wicket gates were rebuilt, and sanded smooth in one day allowing for the finish coat to be applied the following day. Welding would have taken over a week. Prior to involving Belzona, a coating had already been purchased to coat the gates with. Inspection one year later showed some wear on the coating, but no wear on the Belzona 1111.
