Belzona Helps Make Quality Chips

ID: 9457

Industry: *Pulp & Paper*
 Application: *SHM-Solids Handling Machinery*

Substrate: *Carbon steel*
 Products: *Belzona 1811 (Ceramic Carbide)*

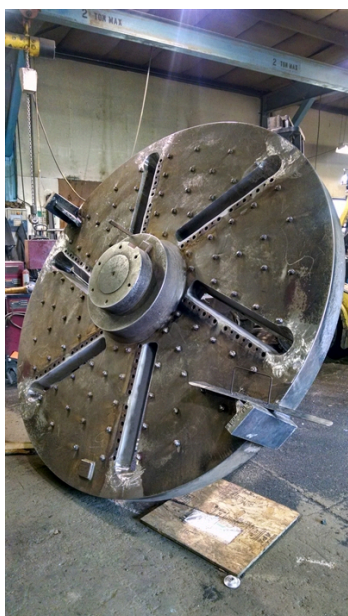
The pockets where the chipper knives are mounted were wearing out.

The chipper disk.

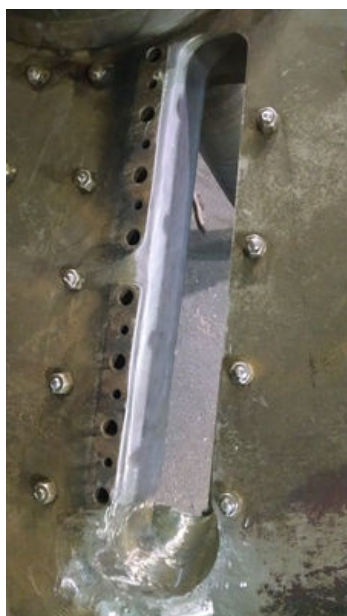
One of the pockets ready for application.

The application surface was prepped by grit blasting, solvent washed, and the Belzona 1811 was applied using the mixing knife, applicator, and by hand. Once the material was firm enough, the surface was smoothed down by hand using soapy water, creating a fine smooth finish.

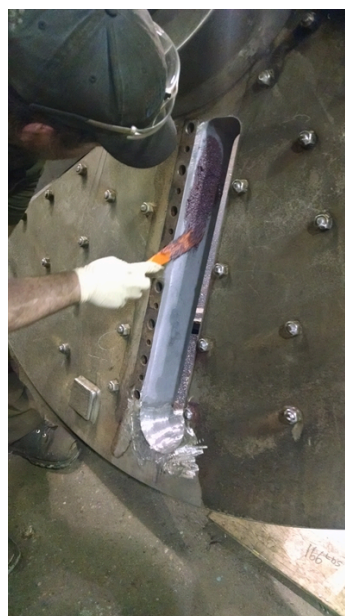
Starting the application.

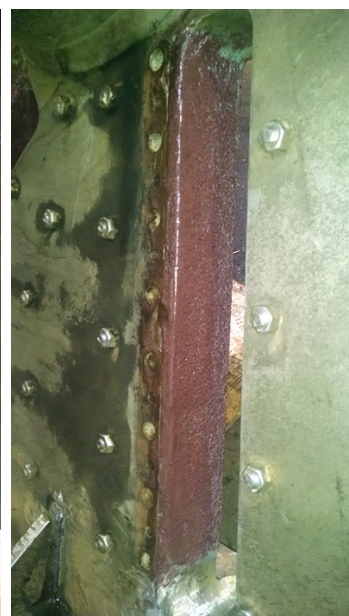
Application completed.

Regular inspections showed minimal wear of the Belzona 1811, much less than the original steel had, and did not require any further attention for 4 years. At that time, as a preventative measure, some additional Belzona 1811 was added to the original material applied in 2015.
