Belzona 1111 Machined Shaft Repair

ID: 9458

Industry: *Marine*
Application: *MPT-Mechanical Power Transmission*

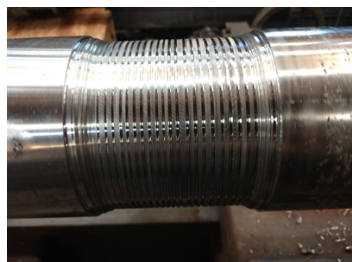
Shaft is mounted on a lathe, and the area has been machined down and roughened, ready for the application.

A lathe was used to prep the area, as well as to remove the excess Belzona 1111. When the Belzona 1111 was applied, it was applied with the lathe turning slowly using a short bristled brush, first scrubbing the material into the roughened surface, and then slowly applying thin layers until the application area was filled out beyond the diameter of the shaft. Applying it in this manner helps to avoid air pockets which result in voids that need to be filled once the shaft is machined down. Should any voids appear during the machining process, additional Belzona 1111 is applied to fill them, allowed to cure, and machined again to the final dimensions.

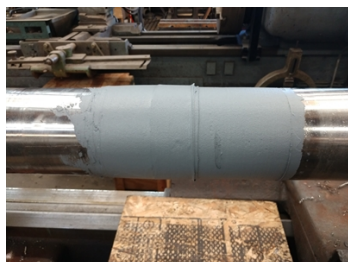
Belzona 1111 applied while the lathe was turning slowly.

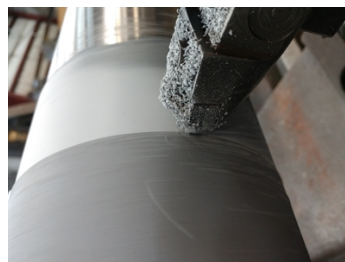
Machining the Belzona 1111 to the proper dimension.

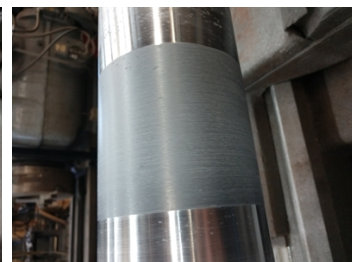
Application completed, fully machined, and dressed down with emery cloth.
