# Belzona 5831 Keeping The Data Cool

Application: HEX-Heat Exchangers

Application Date: February 2016

Products: Belzona 1111 (Super Metal), Belzona 5831 (ST-Barrier)

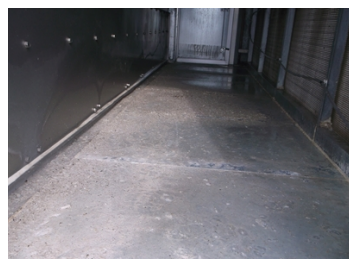
Original condition showing some corrosion.

The cooling tower pans at this data center were beginning to develop corrosion and had already begun leaking in a few small areas.

The application area was prepped using MBX Bristleblasters to achieve a 3-3.5 mil profile. Belzona 1111 was used to address the leaks, and two coats of Belzona 5831 were applied using Belzona 9341 Reinforcement Sheet over the seams for added strength.

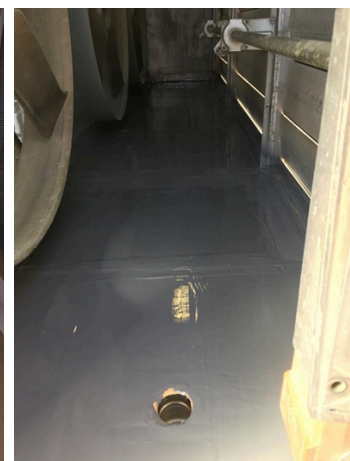
Second coat of Belzona 5831 applied, application complete.
