# Belzona 5831 Keeping The Data Cool

Application: HEX-Heat Exchangers

Substrate: Stainless-steel

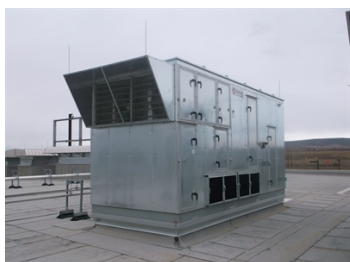
The cooling tower.

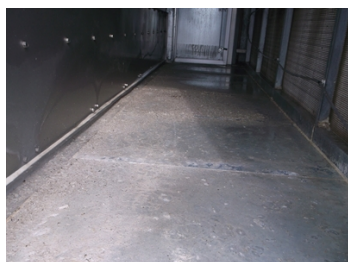
Original condition showing some corrosion.

The cooling tower pans at this data center were beginning to develop corrosion and had already began leaking in a few small areas.

The application area was prepped using MBX Bristleblasters to achieve a 3-3.5 mil profile. Belzona 1111 was used to address the leaks, and two coats of Belzona 5831 were applied using Belzona 9341 Reinforcement Sheet over the seams for added strength.

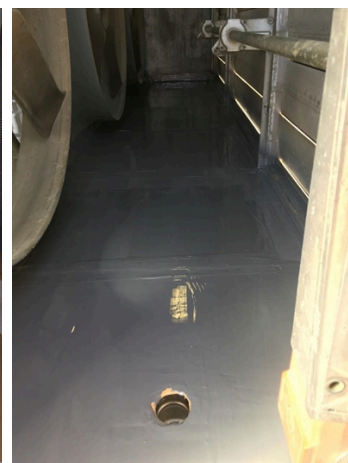
Second coat of Belzona 5831 applied, application complete.
