Belzona 1341 refurbishes a spiral casing on a Francis turbine

Industry: Power
Application: CEP-Centrifugal Pumps
Substrate: Carbon steel
Products: Belzona 1111 (Super Metal), Belzona 1341 (Supermetalglide)

Customer Location: Wales
Application Date: June 2024

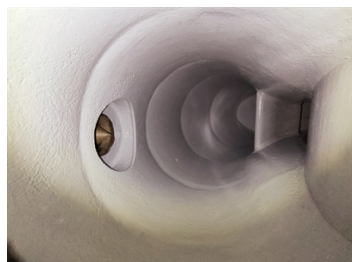
Belzona protective coating from around 2006 was due for a refurbishment

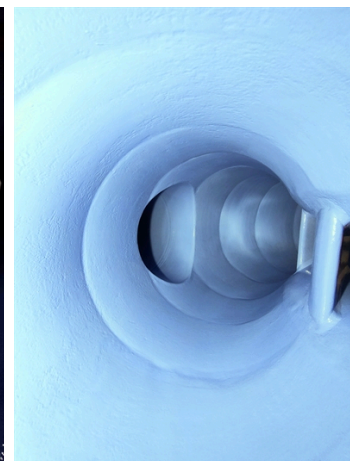
Two coats of Belzona 1341 (Supermetalglide) was applied to Spiral casing.
