Belzona 1321 Solves Cooling Tower Hot Water Basin Seams Leak

ID: 9465

Industry: Power
Application: FPA-Floor Problem Areas
Substrate: Concrete
Products: Belzona 3121 (MR7)

Customer Location: Birmingham, AL
Application Date: December 2023

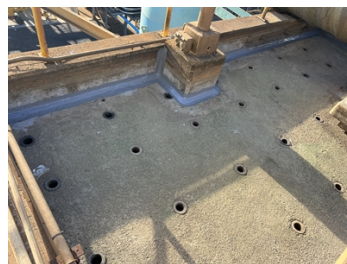
Belzona 3121 Applied with Reinforcement Cloth

We first cleaned the existing joints and removed peeling material or debris. We proceeded to fill in gap areas with backer rod when needed and then applied a concrete material. (Belzona 4111 was overbudget in this case.)

We then applied 1 layer of 3121 and laid the reinforcement cloth engrained followed by a second coat of 1321.

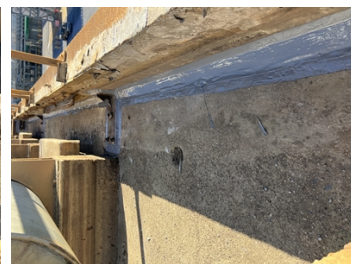
Belzona 3121 Completed
