Stainless Steel Vacuum Pots Seals

ID: 9470

Application: VPF-Valves, Pipes and Fittings

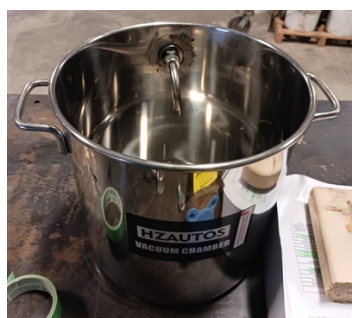
The customer made the purchase of the stainless steel pots and the seal around the fittings started to leak due to the solvents used and was in need of a product that was compatible to be used with hexane, methanol and acetone. each of these solvents are used at different time during the process.

Stainless-Steel Vacuum Pots

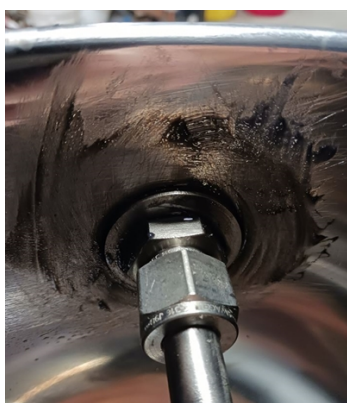
Internal Fitting showing seal of Belzona 2311

The customer removed the fittings and did the pot wall preparation using a 80 grit sanding discs on a grinder and a wire brush onto the fittings. The Belzona 9111 used to clean and degrease the parts, the Belzona 2911 was used on the S/S and than the Belzona 2311 was mixed and applied to all parts than reinstalled, all nuts had been tightened to make the seal and left to cure.

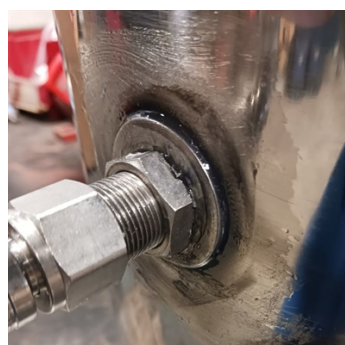
External fitting showing seal of Belzona 2311

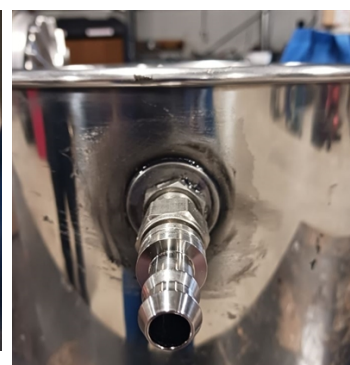
Vacuum pot fitting complete
