Wind Farm Transformer Repair

ID: 9471

Industry: *Power*
Application: *TCC-Tanks and Chemical Containment Areas*
Substrate: *Carbon steel*
Products: *Belzona 1161 (Super UW-Metal), Belzona 5831 (ST-Barrier)*

Customer Location: *Agios Georgios*
Application Date: *June 2024*

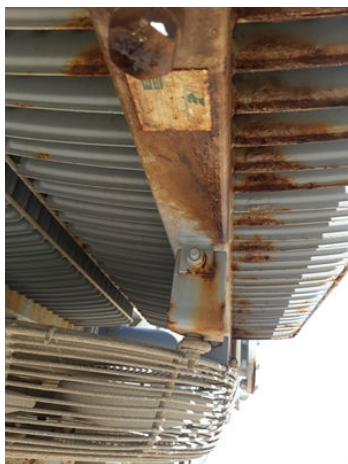
Corrosion and leakage from the cooling channels.

Initial condition illustrating rust and leakage.

Before applying Belzona, the surface was cleaned to get rid of the oil and rust.

Belzona 1161 was used for surface repair in conjunction with Belzona reinforcement sheet 9341.

Belzona 5831 was applied to it for protection following the Belzona 1161 treatment.

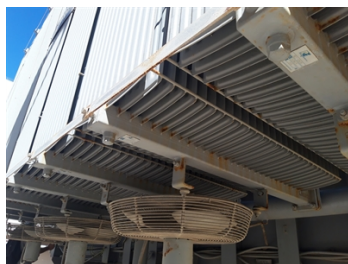
Initial condition illustrating rust.

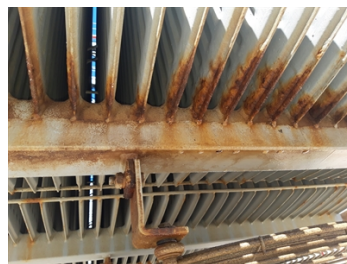
Initial condition illustrating rust and leakage.

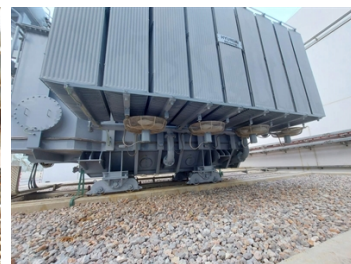
complete application

System Leaflet TCC-1 was followed
