Wind Farm Transformer Repair

ID: 9471

Industry: Power
Application: TCC-Tanks and Chemical Containment Areas
Substrate: Carbon steel
Products: Belzona 1161 (Super UW-Metal), Belzona 5831 (ST-Barrier)

Customer Location: Agios Georgios
Application Date: June 2024

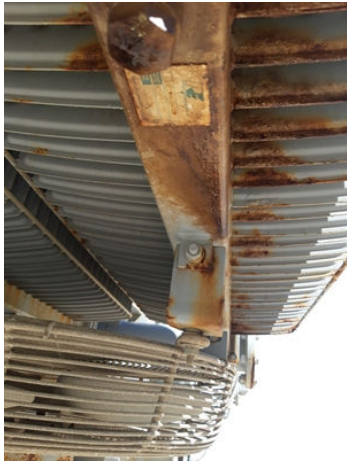
Corrosion and leakage from the cooling channels.

Initial condition illustrating rust and leakage.

Before applying Belzona, the surface was cleaned to get rid of the oil and rust.

Belzona 1161 was used for surface repair in conjunction with Belzona reinforcement sheet 9341.

Belzona 5831 was applied to it for protection following the Belzona 1161 treatment.

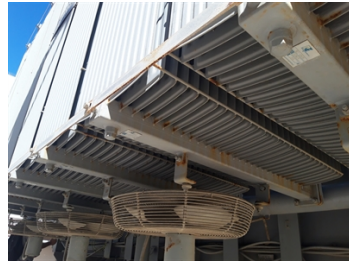
Initial condition illustrating rust.

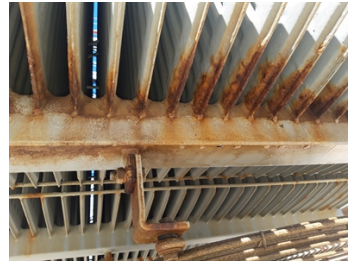
Initial condition illustrating rust and leakage.

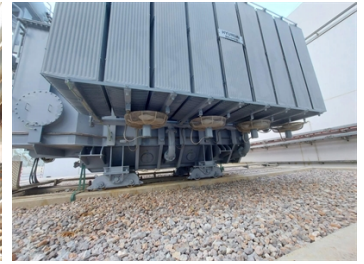
complete application

System Leaflet TCC-1 was followed
