# BELZONA RESTORED THE PROTECTIVE LINING OF CALORIFIER HOT WATER TANK.

ID: 9472

Industry: Heating, Ventilation & Air Conditioning  
Application: TCC-Tanks and Chemical Containment Areas  
Substrate: Carbon steel  
Products: Belzona 5892

Customer Location: HAMAD PORT, DOHA QATAR  
Application Date: June 2024

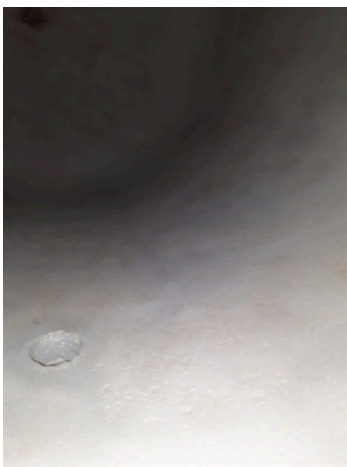
After surface preparation by grit blasting

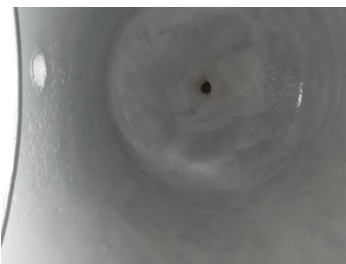
After first coating completed

Application was done using stiff bristled brush only.  
The application was done in accordance with System Leaflet TCC-03

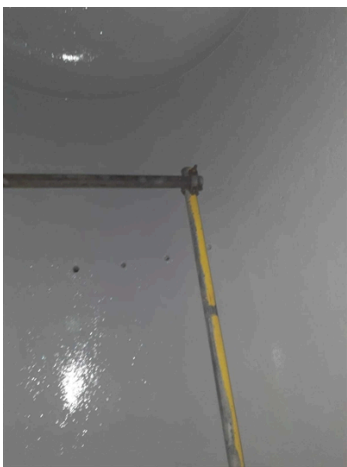
After final coat completed
