Office roof 5 years of protection

ID: 9475

Application: RPA-Roof Problem Areas

Products: Belzona 3131 (WG Membrane), Belzona 3921 (GSC Surface Conditioner), Belzona 3931 (WG Membrane Conditioner)

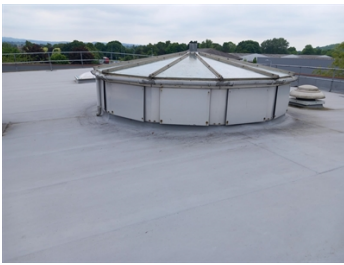
Showing no deterioration to applied Belzona 3131 coating

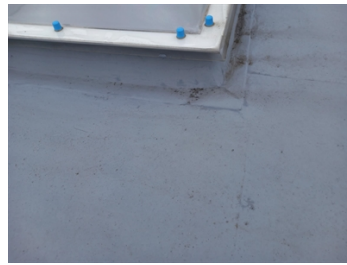
Awkward geometry catered for easily with the Belzona 3131 coating

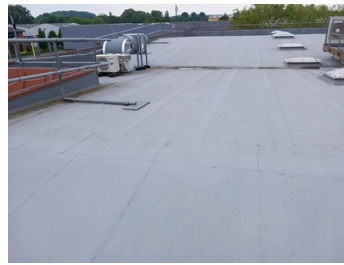
A larger expanse of the main roof where the Belzona 3131 was applied

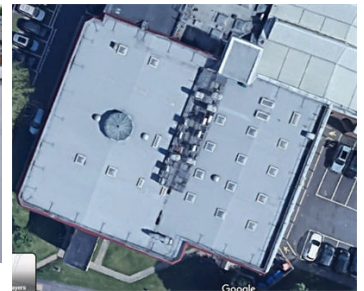
An aerial view of the roof showing a fabulous uniform finish, still looking good after 5 years

obvious issue, but the Belzona 3131 Winter Grade performed brilliantly and is still showing no signs of deterioration 5 years later
