# Blast Enclosure given longer life

**Industry:** General Industry  
**Application:** TCC-Tanks and Chemical Containment Areas  
**Substrate:** Carbon steel  
**Products:** Belzona 1321 (Ceramic S-Metal), Belzona 9111 (Cleaner Degreaser)

**Customer Location:** Peterborough  
**Application Date:** June 2024

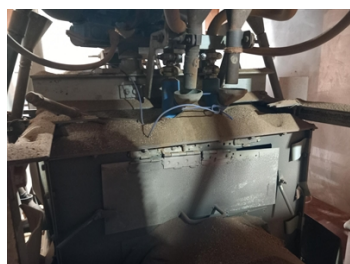
External of the blast enclosure in situ

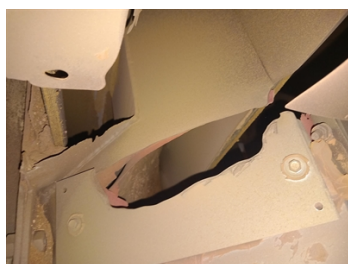
The steel wall plates of the blast enclosure were naturally wearing away by the internal blasting process. This would lead to through-wall and escaping blast media and dust. Eventually the line would have to be stopped and the plates replaced, causing downtime and manpower resource requirements. There was also a cost issue with continually buying new parts

Internal view showing the totally worn away side plates where debris, dust and blast media can escape

The wearing away of the plates were causing the engineers many issues, including a serious Health and Safety risk from flying debris. It was decided to apply two coats of Belzona 1321 Ceramic S metal and have the asset checked at regular intervals. This was with a view to looking out for the base colour showing through the second layer, whereby the engineers on site had agreed to prep up the worn areas and overcoat with more of the second layer, thereby allowing the engineers a visual indicator and a window of opportunity to continually re-treat the most affected areas and save having to take the enclosure apart to rebuild it with new.

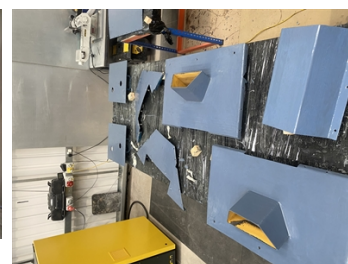
Showing the plates following the application of 2 x colours of Belzona 1321 Ceramic S Metal

New steel parts were delivered to Belzona UK in Hawarden  
The plates were grit blasted to the IFU specs of the Belzona 1321 product  
2 coats (of different colours) of Belzona 1321 were applied to the blasted steel in line with the Belzona 1321 IFU  
Transport was arranged by Belzona to return the plates to site
