# BELZONA REPLACES THE DAMAGED COATING OF BRP PUMP

ID: 9479

Industry: Power  
Application: CEP-Centrifugal Pumps  
Substrate: Carbon steel  
Products: Belzona 5821

Customer Location: RAS LAFFAN QATAR  
Application Date: January 2023

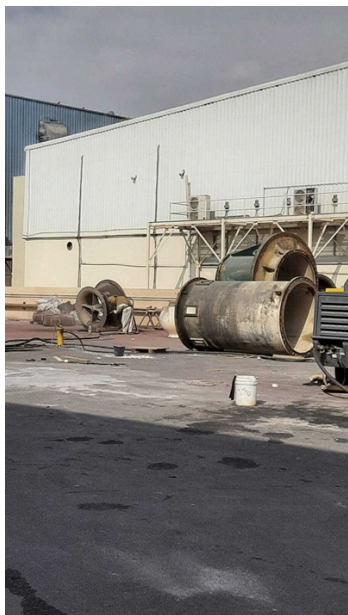
The BRP (Brine Recirculating Pump) was suffering from scattered corrosion due to damage on the existing coating.

BRP pump status before surface preparation

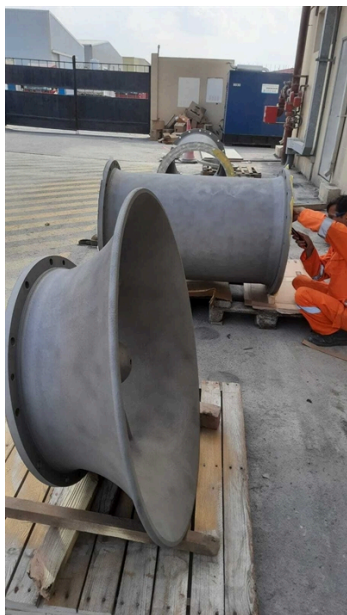
After surface preparation using grit blasting

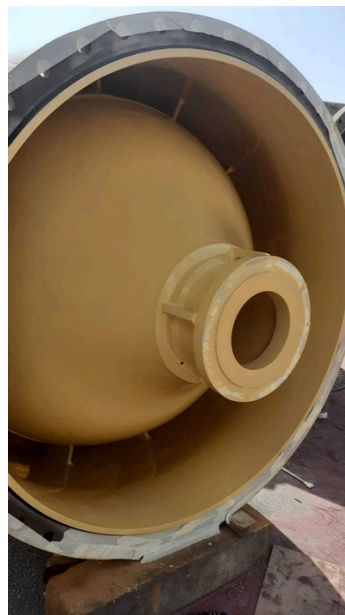
Application of first and second coat was completed and in this is the completed third coat application.

The application was done in 4 coat system due to clients coating thickness requirement is to achieve minimum 600 microns.

Application carried out using only 3 inches stiff bristle brush.

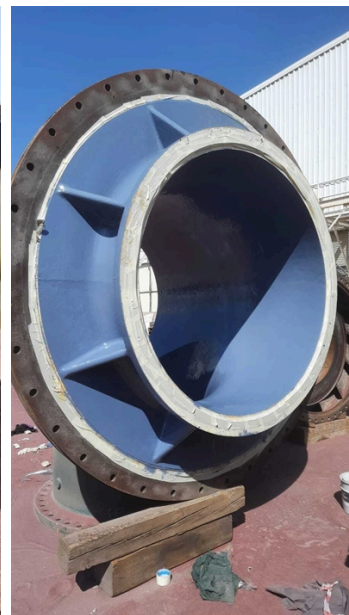
fourth and final coat completed
