# Belzona Protects The Separator From Abrasion

Application: SHM-Solids Handling Machinery

Sichter separator in cement plant.

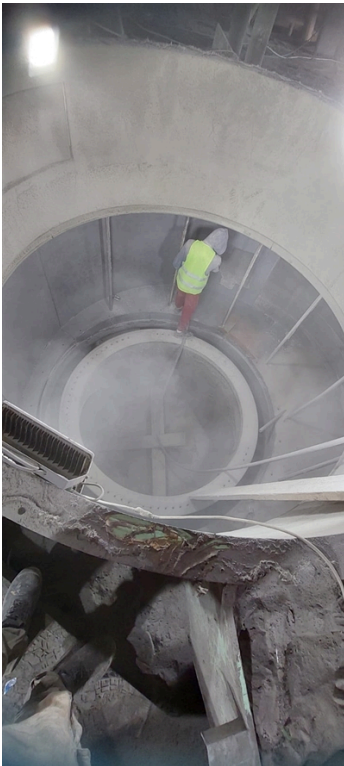
After Blasting
