Repair of PVC pipe with leak from failed fiber glass installation

ID: 9493

Application: VPF-Valves, Pipes and Fittings

Substrate: PVC

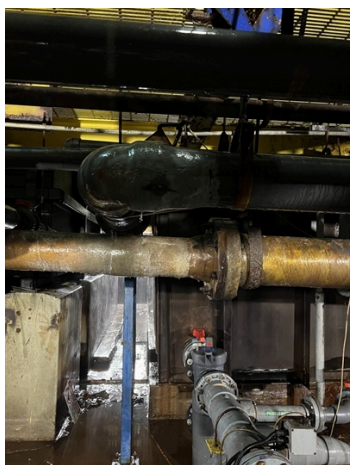
Major leaks was experienced from a failed fiber glass installed earlier by customer to fix problem.

Failed fiber glass

The failed fiber glass was abraded with the aid of a power tool after which the surface was wiped clean using the cleaner/ degreaser Belzona 9111. After drying, Belzona 1212 was mixed and apply with Belzona Super wrap installed afterwards.

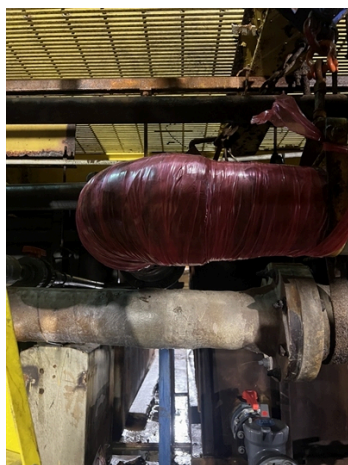
Newly installed Belzona Superwrap II

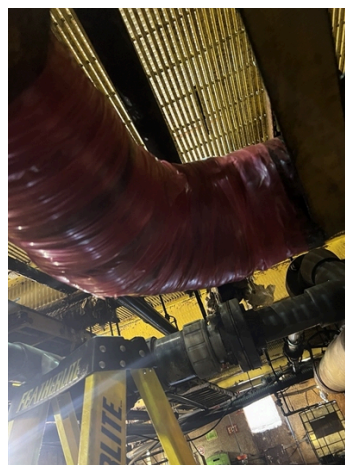
Belzona Super wrap installed successfully.

Belzona was not only able to seal the leak in a couple of minutes but also completed the whole installation and the equipment put back in service as stipulated in the product IFU. Follow up with customer confirmed that there was no leak or sipping as the Super wrap II successfully solve the issue.
