Motor Manufacturer Wash Bay

ID: 9497

Industry: General Industry
Application: TCC-Tanks and Chemical Containment Areas
Substrate: Carbon steel
Products: Belzona 5831LT

Customer Location: Derby
Application Date: September 2019

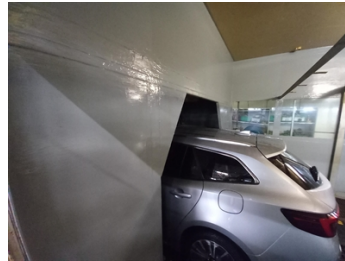
5 years on and the coating is still perfect. The client uses this as an example of their maintenance regime

Belzona 5831LT was applied at 2 coats according to IFU specifications.

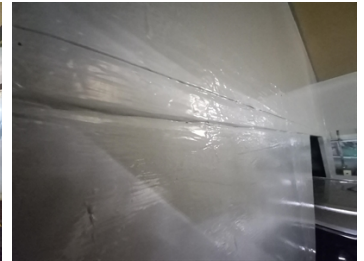
Close up of the coating, 5 years later, in operation 24/7/365
