Application of Belzona on sea water strainer

Customer Location: Mina Abdallah, Kuwait

Substrate: Carbon steel

Products: Belzona 1311 (Ceramic R-Metal), Belzona 1321 (Ceramic S-Metal)

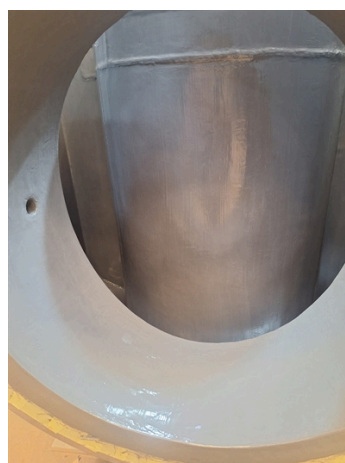
Basically the customer was facing severe corrosion issues, as the strainer was exposed to the sea water. Due the aggressive nature of the sea water, there would be a complete metal loss eventually leading to the leakage of the strainer.

Condition of the shell after exposing to the sea water

1. The entire strainer and cover was grit blasted to obtain near white metal finish.
2. After the grit blasting, the entire dust was removed the using compressor air blower, and degreased to remove the residue
3. Belzona 1311 was mixed & applied to smooth out the welding joints and projections.
4. Belzona 1321 was mixed applied as per the IFU.

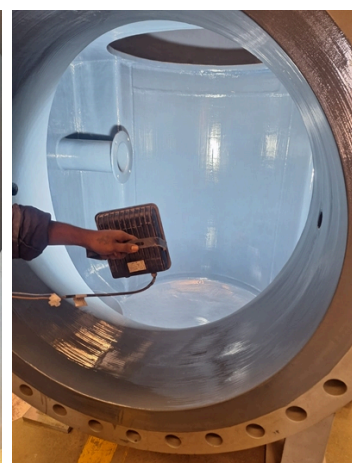
Condition of the shell cover after exposing to the sea water
