# BELZONA SUPERWRAP II APPLICATION ON 24 inch ELBOWS

ID: 9501

Industry: Chemical & Petrochemical  
 Application: VPF-Valves, Pipes and Fittings  
 Substrate: Carbon steel  
 Products: Belzona 1111 (Super Metal), Belzona SuperWrap II

Customer Location: Mina Abdallah, Kuwait  
 Application Date: June 2023

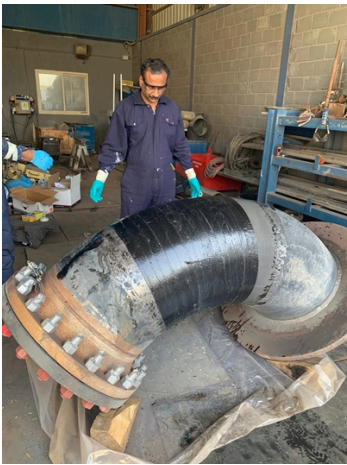
Trial/demo application of Belzona SuperWrap II as per the engineered design.

The Belzona SW II application was carried out in accordance with the design method statement. The elbows were grit blasted to achieve a near white metal finish. The substrate was cleaned and degreased before the application. Belzona 1111 was used to resurface and smooth the weld seams. SW II Belzona 1982 resin and Belzona 9381 245mm width reinforcement tape were applied in accordance with the design specifications."

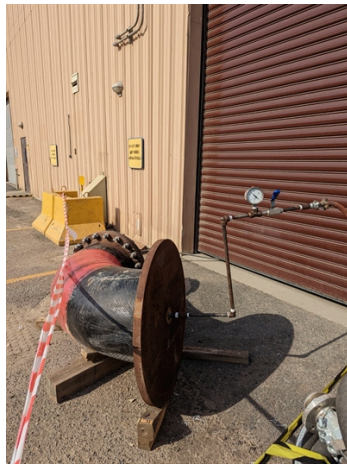
No trace of any leak or peel-off after the completed hydrotest.

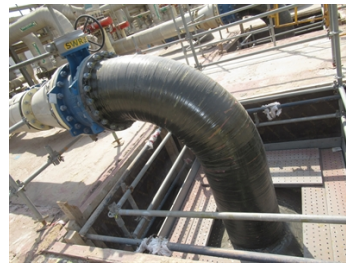
SuperWrap II application for 24-inch elbow of 3.6 m length.

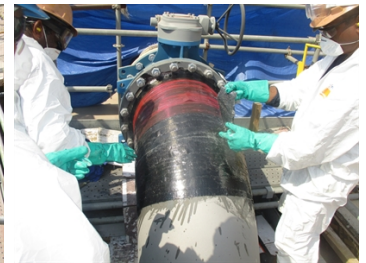
SuperWrap II application by distributor
