REPAIR AND PROTECTION OF HYDRAULIC ROTOR OF MARITIME DOCK

ID: 9503

Industry: Marine
Application: SOS-Ships and Offshore Structures

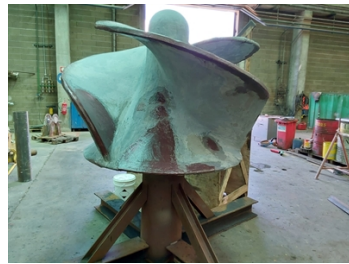
Application of Belzona 1811 (Ceramic Carbide)

The equipment was blasted according to ISO 8501-1 SA 2 1/2 to create the necessary roughness, the salts from marine contamination were removed and the surface was degreased and cleaned with Belzona 9111 Cleaner Degreaser. Belzona 1811 Ceramic Carbide was then applied to fill the worn and cavitated areas, then filled and levelled with Belzona 1121 Super XL-Metal and then a two-layer coating of Belzona 1321 Ceramic S-Metal was applied.

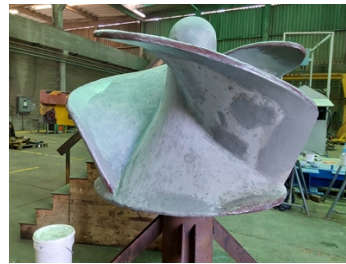
Application of Belzona 1121 (Super XL-Metal)
