# Belzona creates solution for ongoing floor issues

ID: 9505

Industry:	General Industry	Customer Location:	Mansfield
Application:	FPA-Floor Problem Areas	Application Date:	August 2024
Substrate:	Concrete		
Products:	Belzona 2211 (MP Hi-Build Elastomer), Belzona 2911 (Elastomer QD Conditioner), Belzona 4111 (Magma-Quartz), Belzona 4131 (Magma-Screed), Belzona 4911 (Magma TX Conditioner), Belzona 9411 (Release Agent)

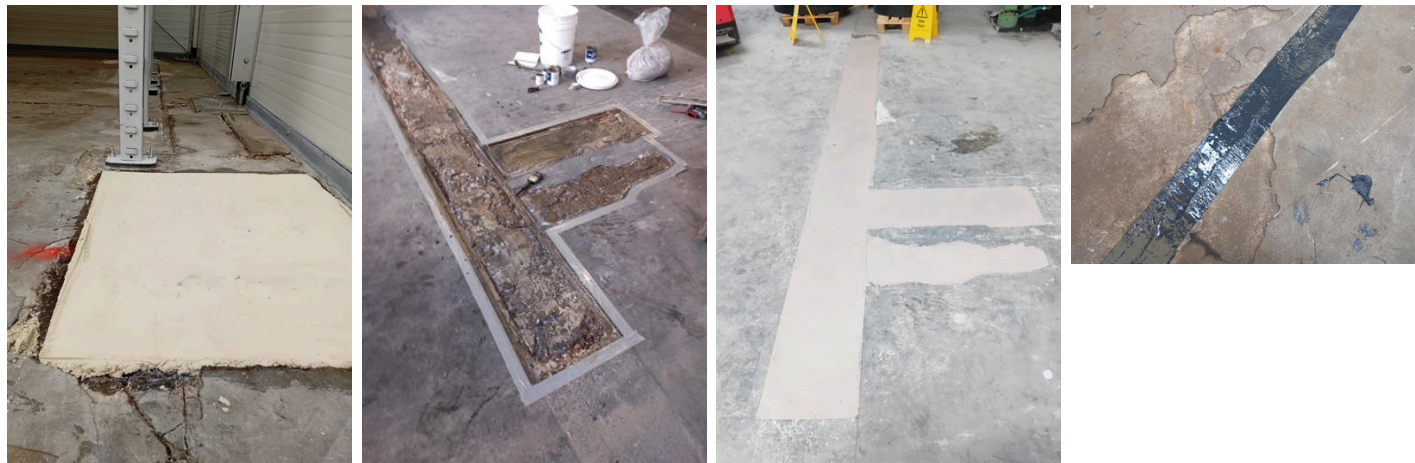
Uneven floor area made good using Belzona 4111 MagmaQuartz to support main racking stanchions	Damaged area prepared and conditioned with Belzona 4911 ready to accept Belzona 4131 MagmaScreed	Damaged area fully repaired, screeded and feather edged with Belzona 4131 MagmaScreed to provide flat safe running surface for fork lift trucks and handling machinery	One of 5 expansion joints raked out, cleaned, conditioned with Belzona 2911 Conditioner and finished with Belzona 2211 Hi-Build elastomer
---	--	--	---

Whilst that was drying, the concrete areas were conditioned with Belzona 4911 TX Conditioner and Belzona 9411 release agent was applied to a wooden former for the Belzona 4111 pad for the racking.

The Belzona 4111 was mixed as per the IFU using a Daines Mixer and applied to the target area, compressing and smoothing it over with a finishing trowel. The same was done (without former) to the larger damaged area, this time using Belzona 4131.

The Expansion joint was then finished using Belzona 2211 to a masked area using applicators to create a smooth finish and removing the masking tape immediately
