Belzona repairs flange and offers protection against corrosion

ID: 9506

Industry: Chemical & Petrochemical
Application: VPF-Valves, Pipes and Fittings
Substrate: Carbon steel
Products: Belzona 1311 (Ceramic R-Metal), Belzona 1321 (Ceramic S-Metal), Belzona 9411 (Release Agent)

Customer Location: Petrochemicals, Brazil
Application Date: August 2015

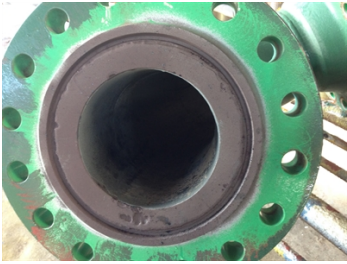
An RTJ flange at a petrochemical plant was exposed to high salt and H₂S content from the pumping activities, leading to a loss of substrate and subsequent leakage.

Damaged flange face due to high salt and H₂S content

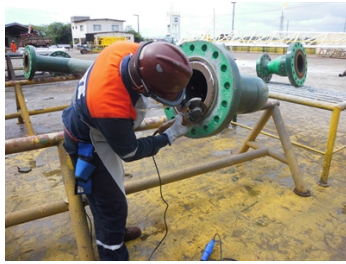
Surface preparation on the groove

After hydro-blasting with ultra high pressure for decontamination, salinity measurement and abrasive blasting were performed on the flange surface to achieve the SA 2 1/2 standard.

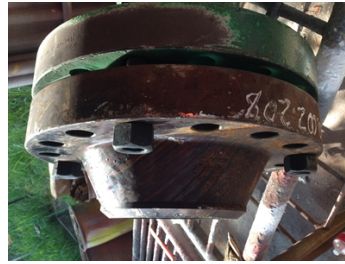
RTJ groove shaping

The application was then carried out in accordance with Belzona Know-How System Leaflet VPF-9 and VPF-13 to restore the flange profile.

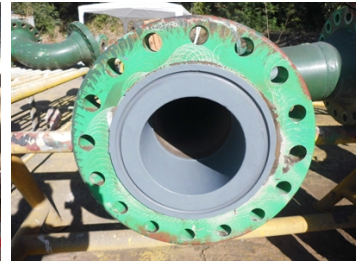
Flange face repair complete and ready to put back in service

The flange was subjected to a pressure of 150 kgf/cm² and this application method was approved to be used on all flanges in the station. There was no need to replace the flanges with new ones to stop the leaks. This repair solution helps improve efficiency in the field and environmental preservation.
