# Belzona repairs flange and offers protection against corrosion

ID: 9506

Application: VPF-Valves, Pipes and Fittings

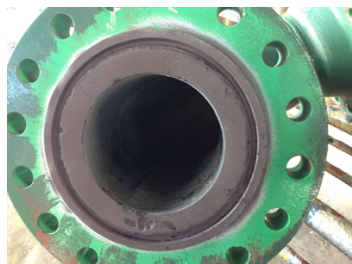
An RTJ flange at a petrochemical plant was exposed to high salt and H<sub>2</sub>S content from the pumping activities, leading to a loss of substrate and subsequent leakage.

Damaged flange face due to high salt and H<sub>2</sub>S content

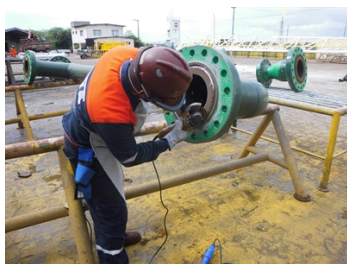
Surface preparation on the groove

After hydro-blasting with ultra high pressure for decontamination, salinity measurement and abrasive blasting were performed on the flange surface to achieve the SA 2 1/2 standard.

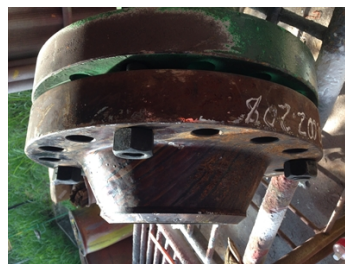
RTJ groove shaping

The application was then carried out in accordance with Belzona Know-How System Leaflet VPF-9 and VPF-13 to restore the flange profile.

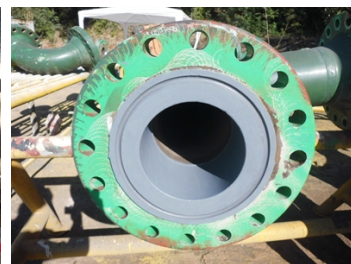
Flange face repair complete and ready to put back in service

The flange was subjected to a pressure of 150 kgf/cm<sup>2</sup> and this application method was approved to be used on all flanges in the station. There was no need to replace the flanges with new ones to stop the leaks. This repair solution helps improve efficiency in the field and environmental preservation.
