Belzona Expansion Joint Solution at Hospital

Industry: Buildings & Structures
Application: FPA-Floor Problem Areas
Substrate: Concrete
Products: Belzona 2211 (MP Hi-Build Elastomer), Belzona 2911 (Elastomer QD Conditioner), Belzona 4231 (E Magma-Quartz), Belzona 5231 (SG Laminate)

Customer Location: Murfreesboro, TN
Application Date: October 2023

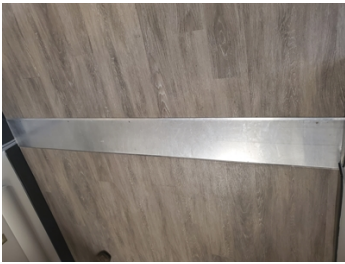
Customer had metal plate over expansion joint that was a trip hazard as well as being uncomfortable for patients to cross on a hospital bed.

Metal plate was installed when hospital was renovated and was a trip hazard.

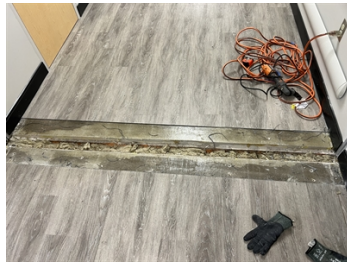
Plate Removed area was cleaned and backer rod was added.

The Metal plate was removed, and joint was cleaned out. Edges of the concrete was rebuilt with Belzona 4131. Backer rod was inserted in the void area and Belzona 2211 was used to form the joint. Belzona 5231 was used as the topcoat to meet up with the existing floor.

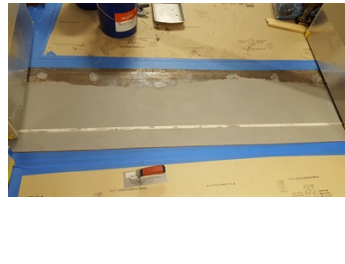
Joint was rebuilt with Belzona 4131, Belzona 2211 was used to form the joint and Belzona 2911 conditioner was used as a primer.

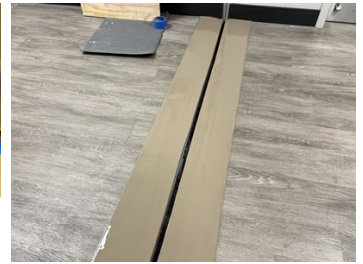
Belzona 5231 was used as the topcoat.
