# Belzona floor repair

ID: 9517

Application: FPA-Floor Problem Areas

Substrate: Concrete

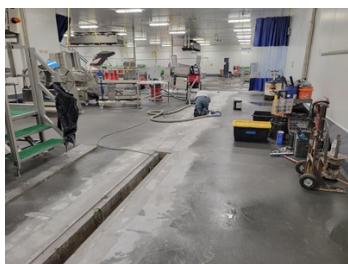
The floor was prepped with hand tools, cleaned and then repaired whit Belzona 4111.

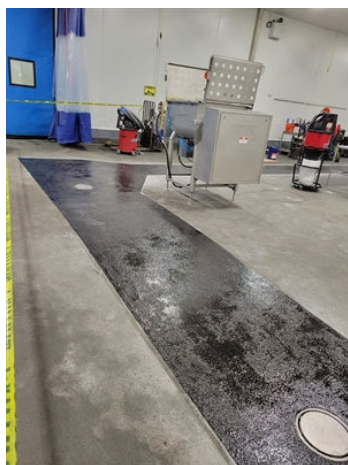
First coat of Belzona 5811 black on floor for protection

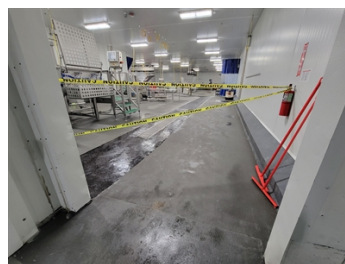
Second and final coat of Belzona 5811

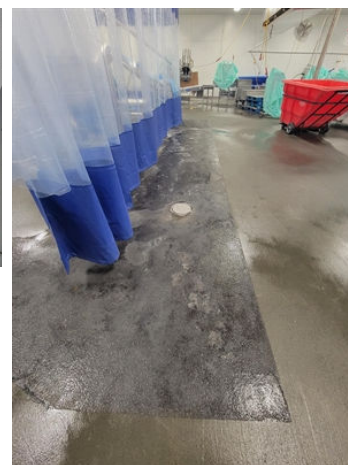
The floor 2 weeks after Application
