Belzona Solution for Contact Coolers

ID: 9519

Industry: *Marine*
Application: *SOS-Ships and Offshore Structures*

Substrate: *Carbon steel*
Products: *Belzona 1121 (Super XL-Metal), Belzona 5821*

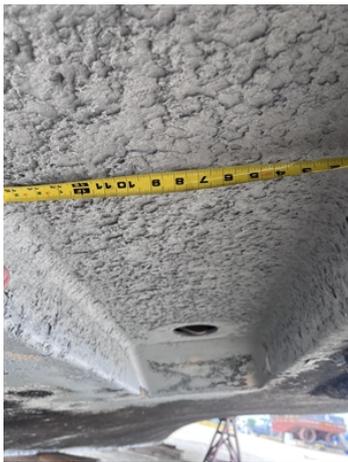
Customer was seeing significant erosion under contact cooler on bottom of boat.

Before Application
