BELZONA REPAIRS MEG TANK HOLED BY CUI

ID: 952

Customer Location: Oil Major St Fergus Gas plant, Scotland
Application Date: May 2006

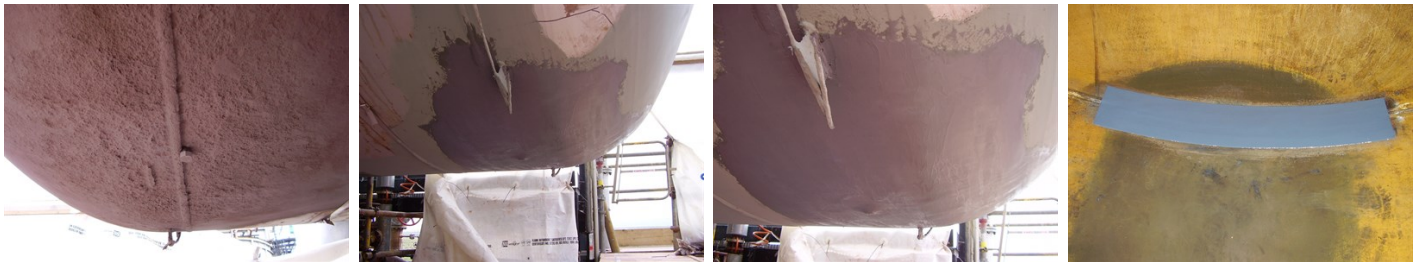
Photograph Descriptions

Corrosion Under Insulation (CUI) on the vessel had caused a pin hole in the vessel wall

- * CUI with pinhole drilled, threaded and bolted ,
- * Application of Belzona® 1111 ,
- * Completion of the Application of the Belzona® 1111 externally ,
- * Application of Belzona® 1111 & 1321 internally over the bolt ,

Hot work was not allowed on site without a major shut down. Belzona sealed leak and provided protection to surrounding area to prevent future problems of CUI.
