Belzona Seals Leaking SF6 Flange

ID: 9521

Customer Location: London
Application Date: May 2024

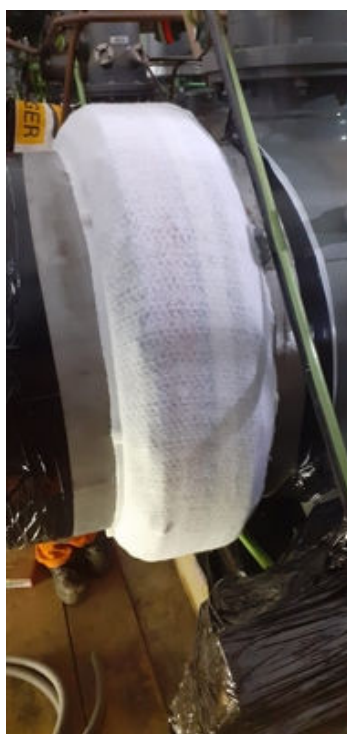
Repair area substrate prepared utilising bristle blaster and breather membrane installed.

The application area was prepared using MBX (Bristle Blaster). Stainless steel wheels were used as the substrate was aluminium. Substrate was degreased using Belzona 9111 to remove any contaminants.

Breather pipe and 3D printed base plate were installed at 6 o'clock position as SF6 is heavier than air.

Breather membrane was installed tightly to the profile of the flange due to restricted access from near-by components. Breather pipe was allowed to protrude through membrane.

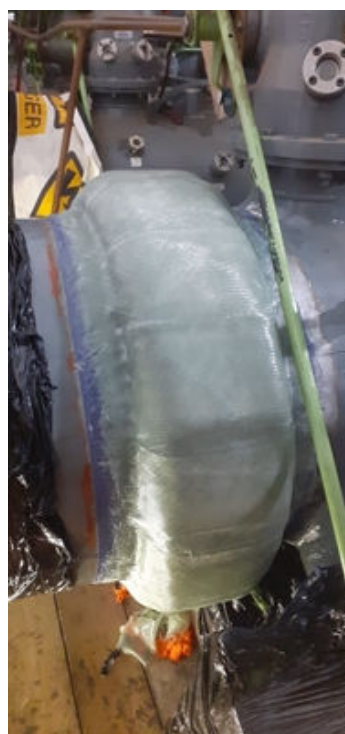
Belzona 7311 applied to repair area incorporating Belzona 9341. 5x layers of Belzona 9371 using Belzona 1981 resin for wetting.

A combination of Belzona 7311 and 9341 along with Belzona 1981 and Belzona 9371 were used to encapsulate the full circumference of the flange.

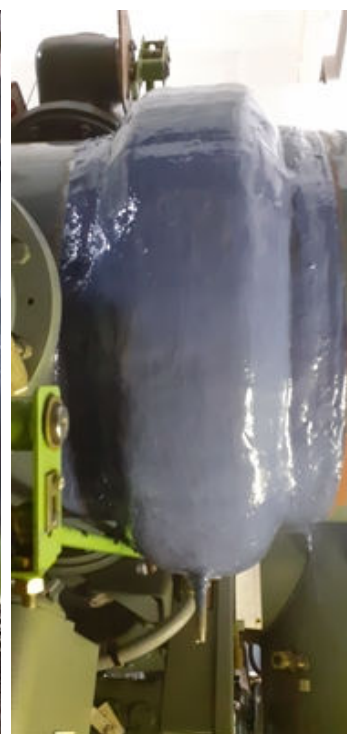
SF6-FIX leak sealing repair completed, with vent pipe left open at 6 o'clock position until full cure is achieved. Vent pipe is capped off following full cure.

The breather pipe was left to vent until all materials used in the repair had achieved full cure. The vent pipe was then capped off and the system repressurised.
